NASA/ASEE SUMMER FACULTY FELLOWSHIP PROGRAM

MARSHALL SPACE FLIGHT CENTER  
THE UNIVERSITY OF ALABAMA IN HUNTSVILLE

MICROSTRUCTURAL ANALYSIS OF  
THE 2195 ALUMINUM-LITHIUM ALLOY WELDS

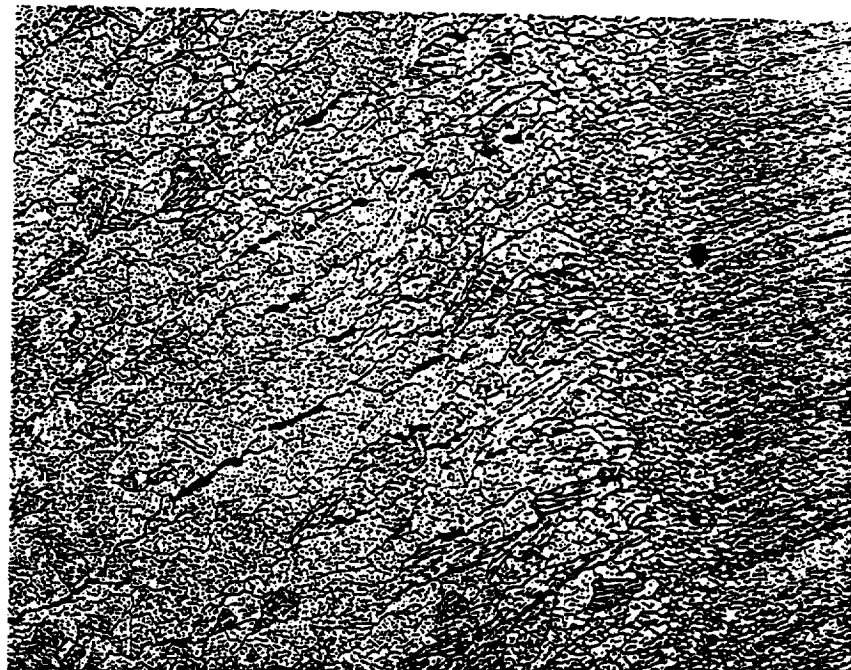
Optical micrographs of the fusion zone of a single pass and two-pass welds in 2195 Al-Li alloy are shown in Figure 1. The initial metallographic analysis of the single pass weld revealed a well formed grain structure with a small amount of porosity. This porosity compares with the initial porosity of the parent metal. See Figure 1-a. For two pass welds a large amount of porosity is observed in the first pass fusion zone (but not in the second or cover pass) and some of the pores take a crack-like shape as shown in Figure 1-b.

Figure 1.- Optical micrographs of 2195 Al-Li alloy subjected to (a) a fusion pass weld and (b) a fusion pass plus a heating (but not melting) cover pass.

a) Reheating (e.g., by a cover pass) generates both round porosity and crack-like porosity observed in 2195 Al-Li Alloy welds.

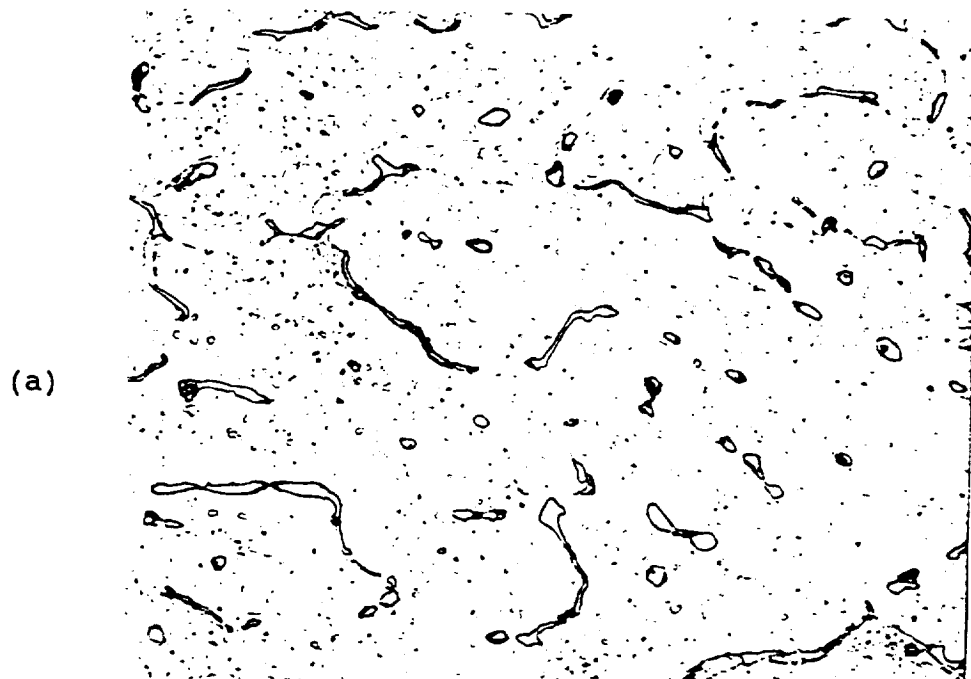
in Figure 2. Figure 2-a presents a microstructure similar to the as-welded materials. In contrast, the air-heated Al-Li alloy shows evidence of a dendritic or grain boundary reaction. See Figure 2-b. In addition to the solid state boundary reaction, an increase in the porosity was observed in the air-heated material.

Figure 2.- Micrographs showing the effect of the heating at 450 C for a minute in vacuum (a) and in air (b).

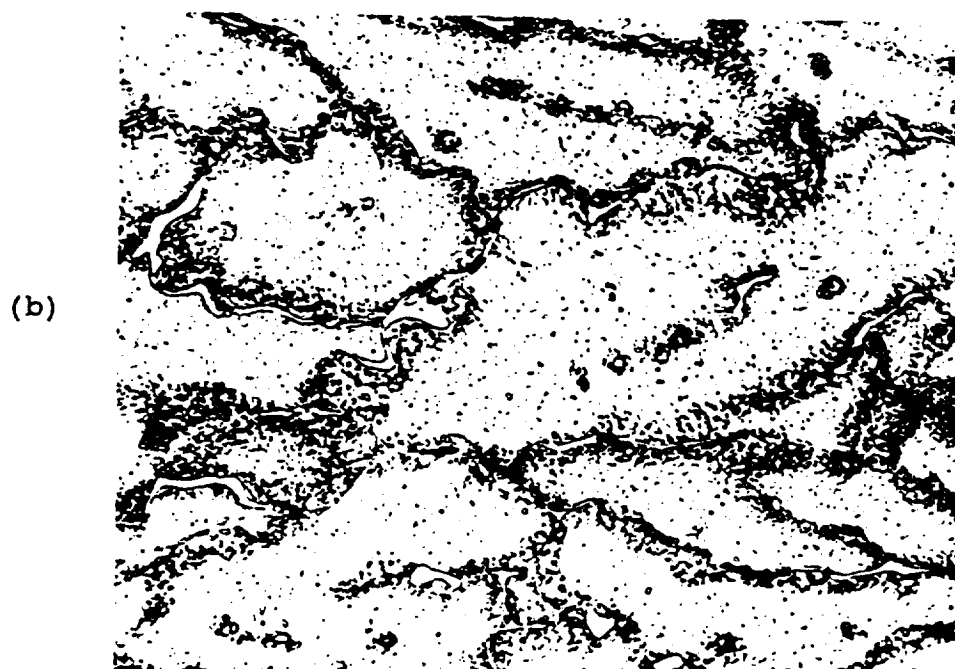
Chemical analysis of Al-Li alloy 2195 base and weld metal indicated hydrogen contamination at levels much higher than expected for Alloy 2219, which lacks lithium. It is conjectured that the hydrogen is present in the form of a lithium compound. When the welds are heated in air, nitrogen penetrates rapidly into the material along dendritic boundaries. Then it begins to diffuse into the solid metal. When it encounters a hydrogen-lithium compound, replaces and releases hydrogen as a gas. At elevated temperatures high gas pressure forms porosity and promotes cracking.
